EWING DAM

LEWIS COUNTY, MISSOURI

MO 10218

**PHASE I INSPECTION REPORT
NATIONAL DAM SAFETY PROGRAM**

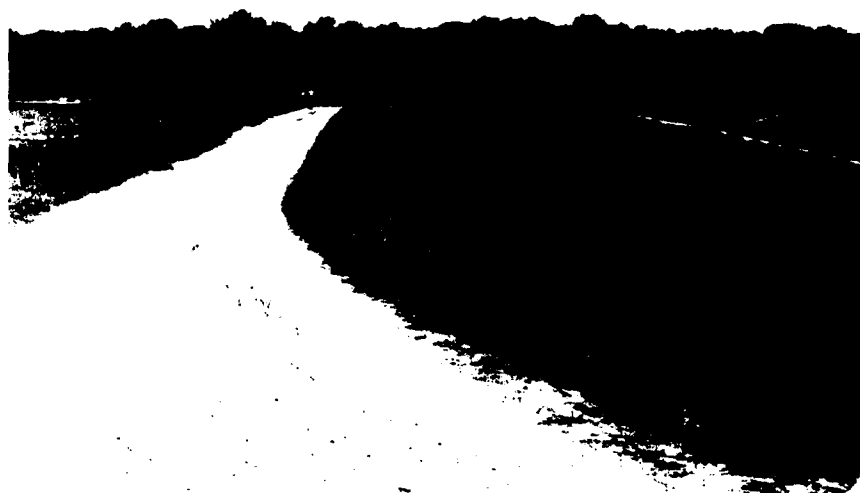
Photo 1 - View along crest of dam taken at right abutment.

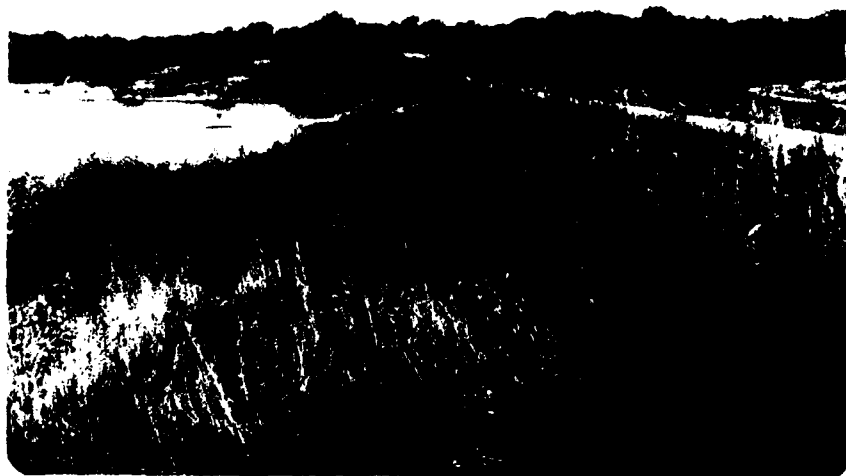
Photo 3 - View along upstream slope of dam taken at right abutment.

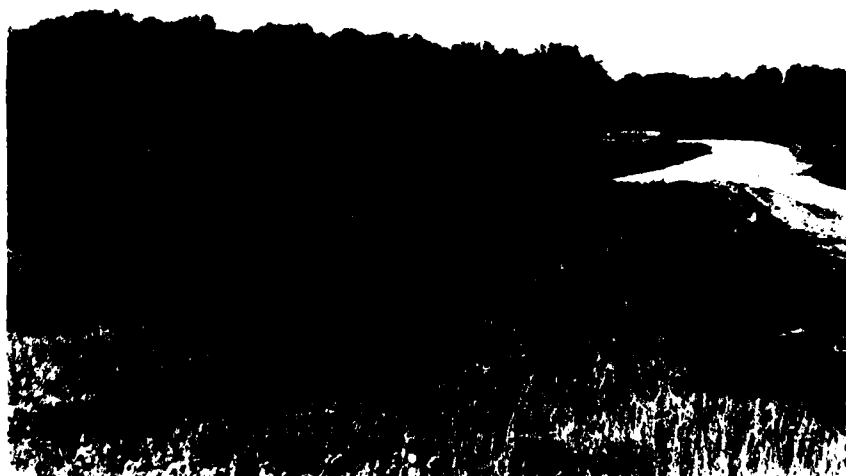
Photo 4 - View along downstream slope of dam taken at left abutment of dam.

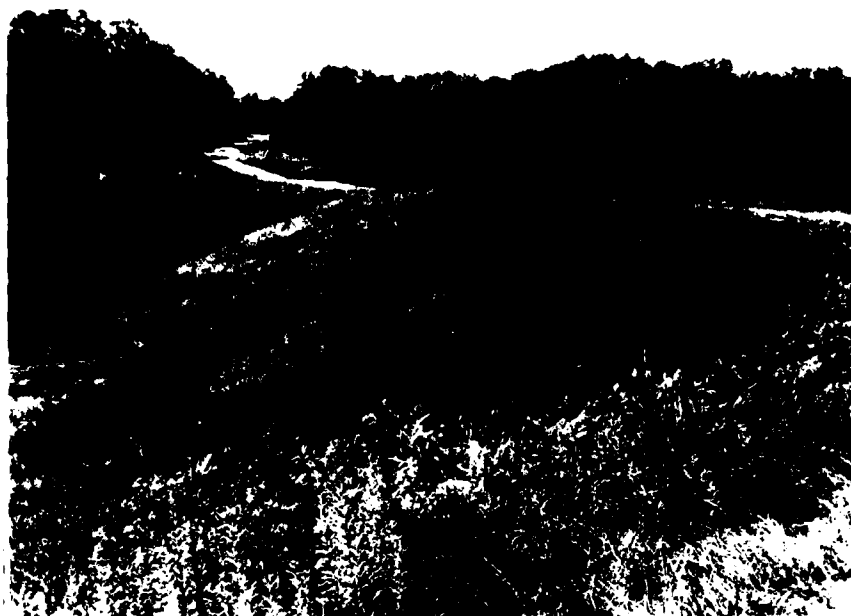
Photo 5 - View along downstream slope of dam taken at left abutment.

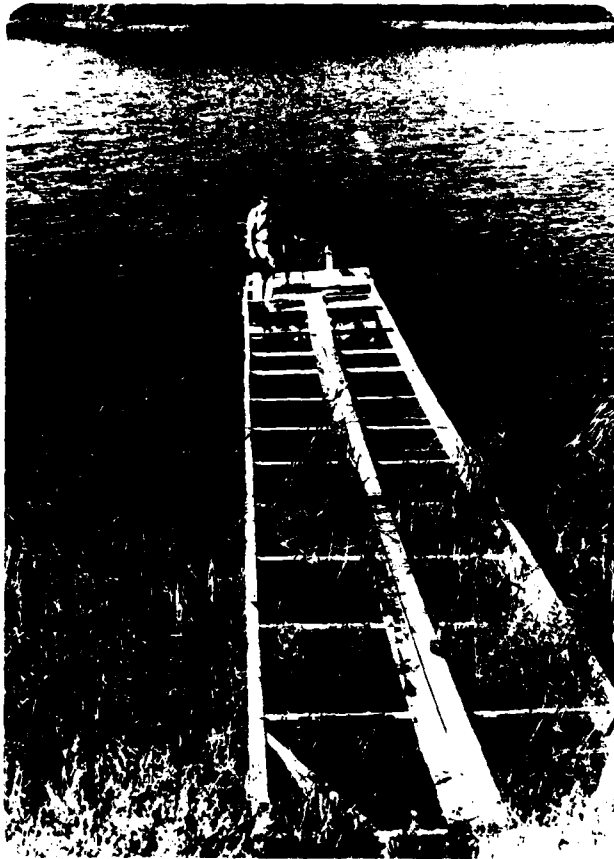
Photo 7 - Picture of intake structure and hoist for water supply piping.

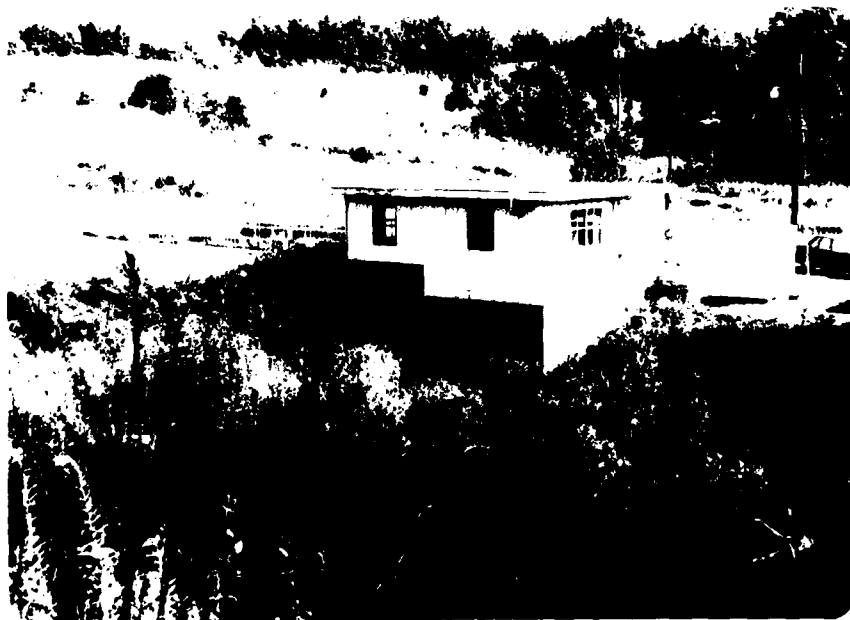
Photo 8 - Picture of water supply pump house.

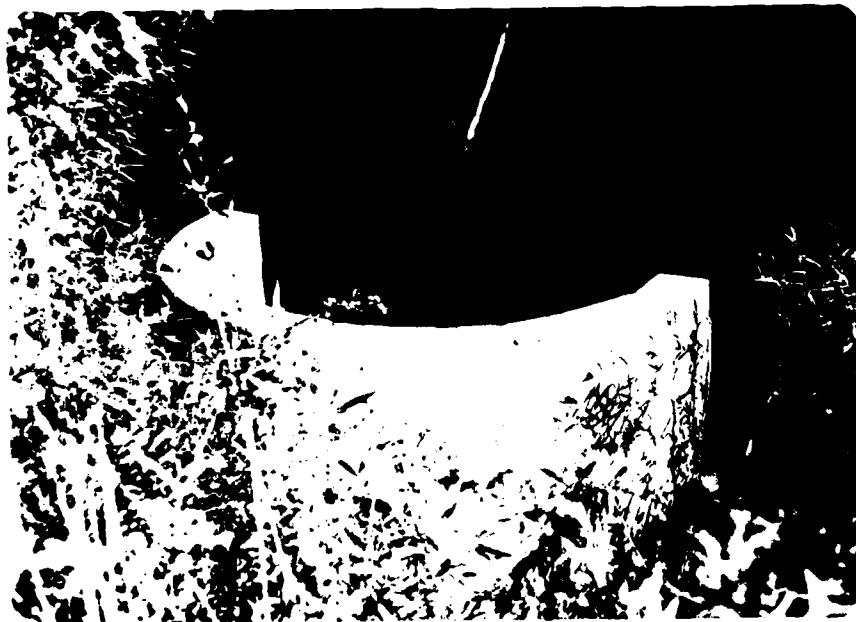
Photo 9 - Picture of concrete block shaft which receives water from settling basin overflow and backwash cycle.
